Technical Memorandum No. 33-81

**Investigation of Hailstorm Damage
to DSIF Antennas**

(Preliminary Report)

JET PROPULSION LABORATORY
CALIFORNIA INSTITUTE OF TECHNOLOGY
PASADENA, CALIFORNIA

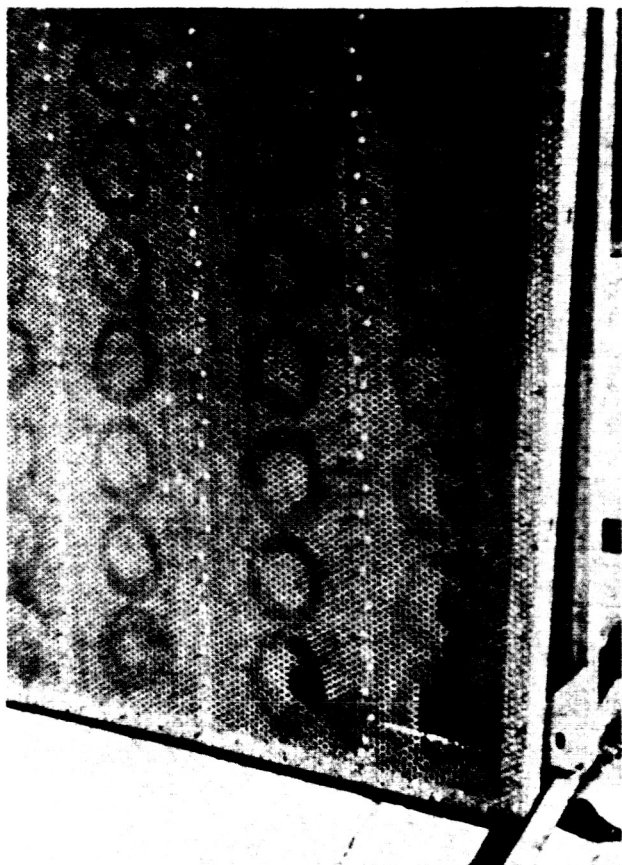
The tests show that a hailstone of 1/2-in. diameter will cause a surface dent of 1/8 in. or greater. This surface damage increases up to a depth of 1-1/2 in. with increasing hailstone diameters. When the hailstone diameter reaches between 1 and 1-1/2 in., the surface is torn and holes occur. Figure 5 shows a panel impacted by 1-1/2-in.-diameter hailstones.

- D. If a severe hailstorm occurs at any of the sites, it will critically affect the surface of the existing antenna panels (see Figs. 5 and 6).
- E. In a severe hailstorm, hail damage of unresolved levels will occur to such hardware as feed assemblies, waveguide, drive-system components, readout-system components, electronic-cage hardware, warning and structure lighting, optical tooling, and boresight instrumentation.

Fig. 5. Expanded aluminum-screen-surfaced panel after hailstone impacts

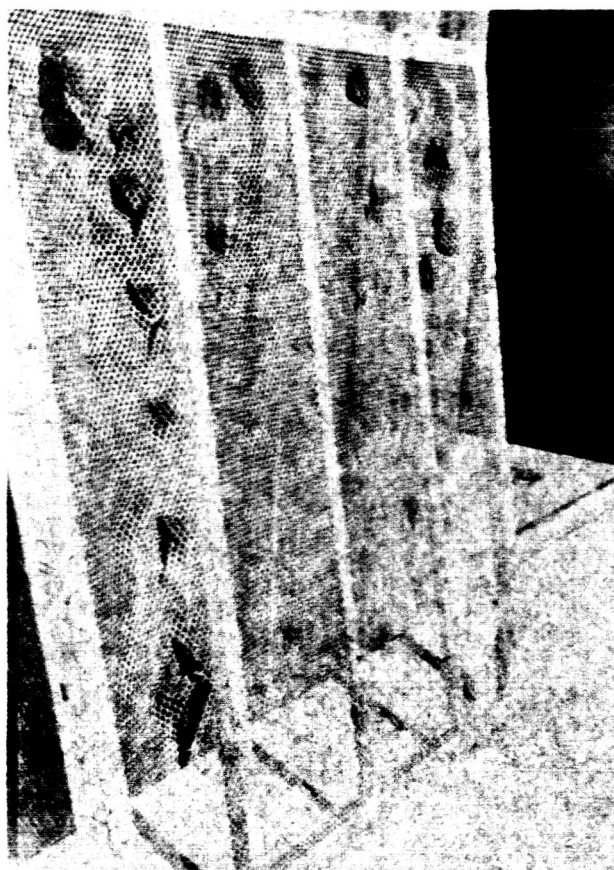
The tests show that for hailstones of diameters below $1/2$ in., the perforated plate is not damaged. A 1-in. hailstone produces a $1/16$ -in. dent or greater; the surface damage increases to a depth of $1/2$ to $3/4$ in. when impacted by 2- to $2-1/2$ -in. -diameter hailstones. The plate cracks and some holes appear when impacted with hailstones of diameters between $2-1/2$ and 3 in. Figure 6 shows a position-related impacted panel. The holes in the lower right were produced by 3-in. hailstones. The third circle on the upper right-hand side shows a crack which was produced by a $2-1/2$ -in. hailstone.

Fig. 6. Perforated aluminum-plate-surfaced panel after hailstone impacts

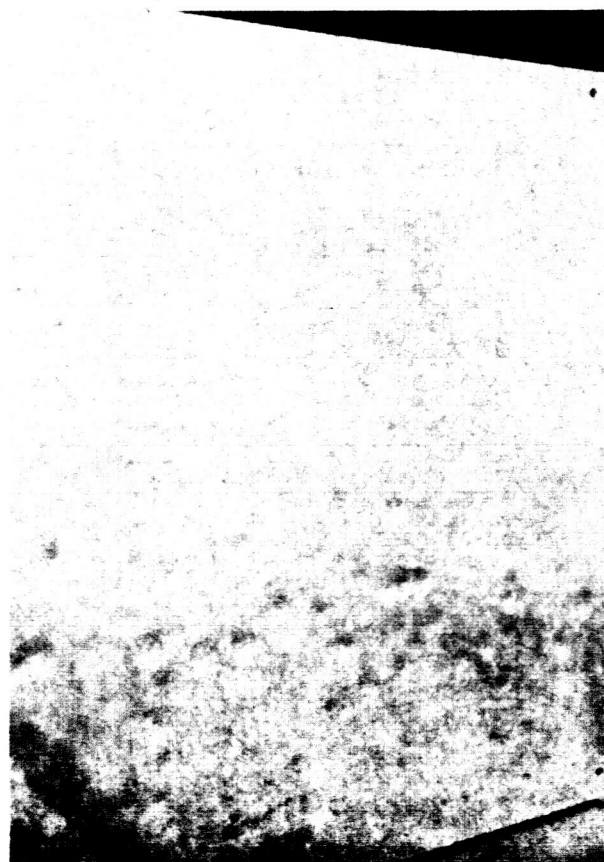
The tests show that impacts by $1/2$ -in. -diameter hailstones produce dents of $1/64$ to $1/16$ in. This surface damage increases to depths of $1/2$ in. with increasing hailstone size to the maximum expected diameter. While no cracking or tearing of the surface ever occurred, the multiple impacts on the panel caused the surface plate to separate from the honeycomb core. Figure 8 shows a panel

impacted by 1-1/2-in. -diameter hailstones at the expected density; dents run from 1/16 in. for 1/2-in. hailstones to 1/2 in. for 3-in. hailstones.

Fig. 8. Aluminum-plate honeycomb-core panel after hailstone impacts

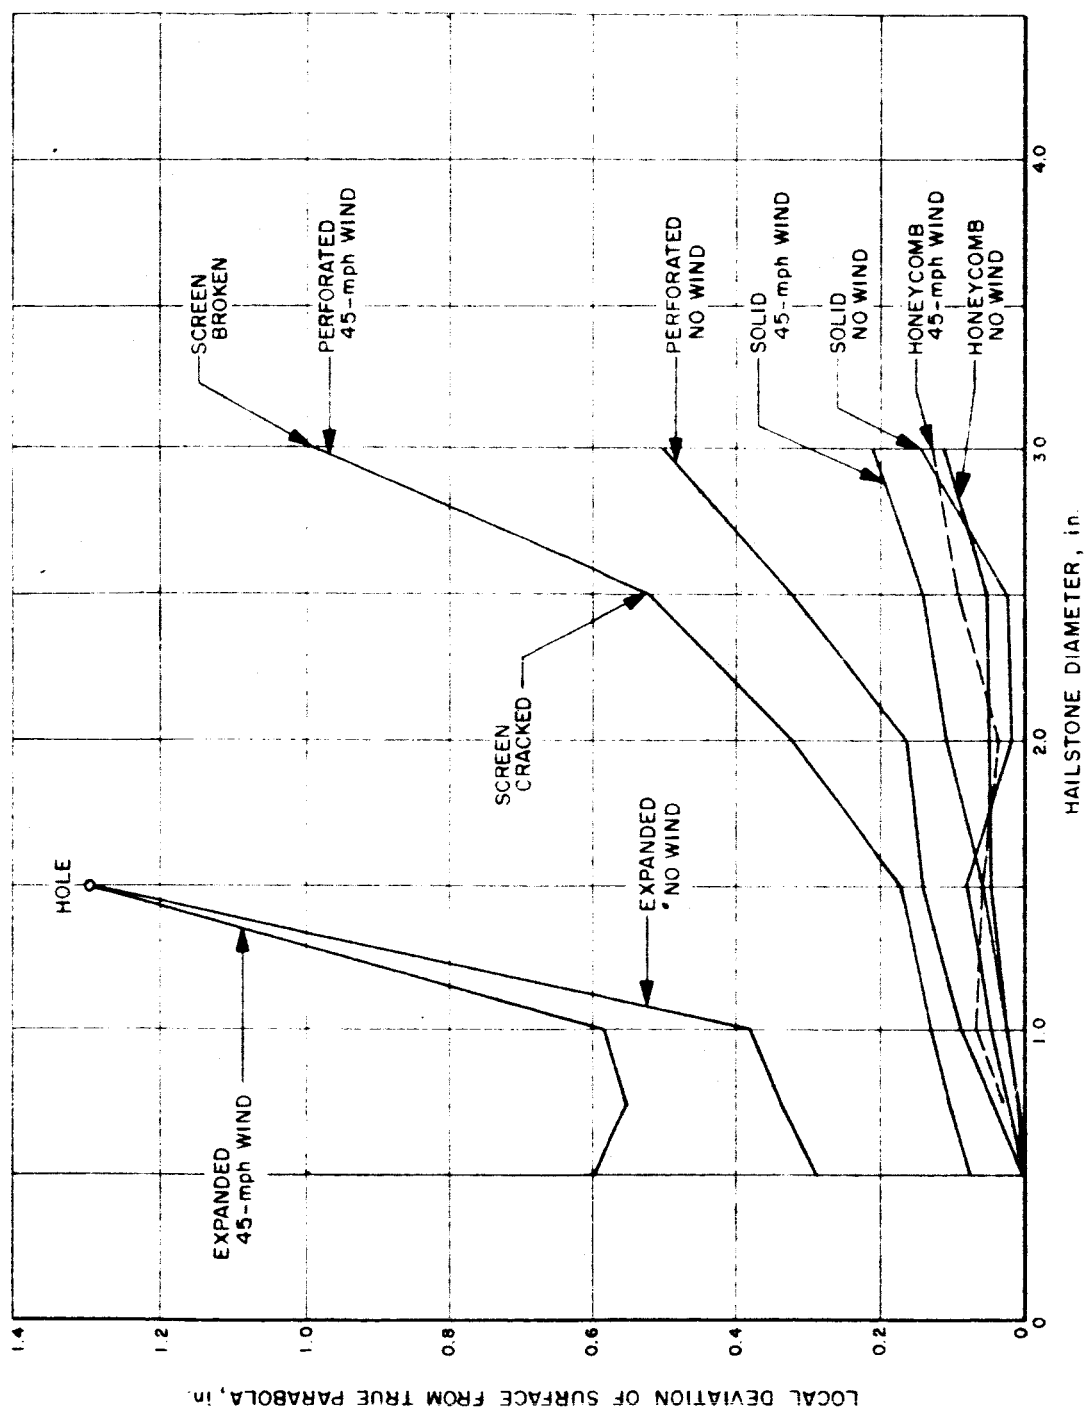
Based on preliminary data taken from the position-impacted panels, the curves of Figs. 9 and 10 were compiled. These Figures show the deviation of the surfaces of the panels from a paraboloid for single and multiple hailstone impacts and for no wind and 45 mph winds, on all four types of panels.

Figures 11, 12, and 13 show that the surface plate and core have delaminated and the surface plate has partially sprung back, indicating less surface damage. When delamination did not occur, the surface damage was comparable to core damage for similar impact energies. As future panels would necessarily have a more positive bonding to prevent eventual delamination of the whole surface plate, it is apparent that the "honeycomb" curves of Figs. 9 and 10 would be worse by a factor of perhaps 2 to 3.

Fig. 9. Single impacts

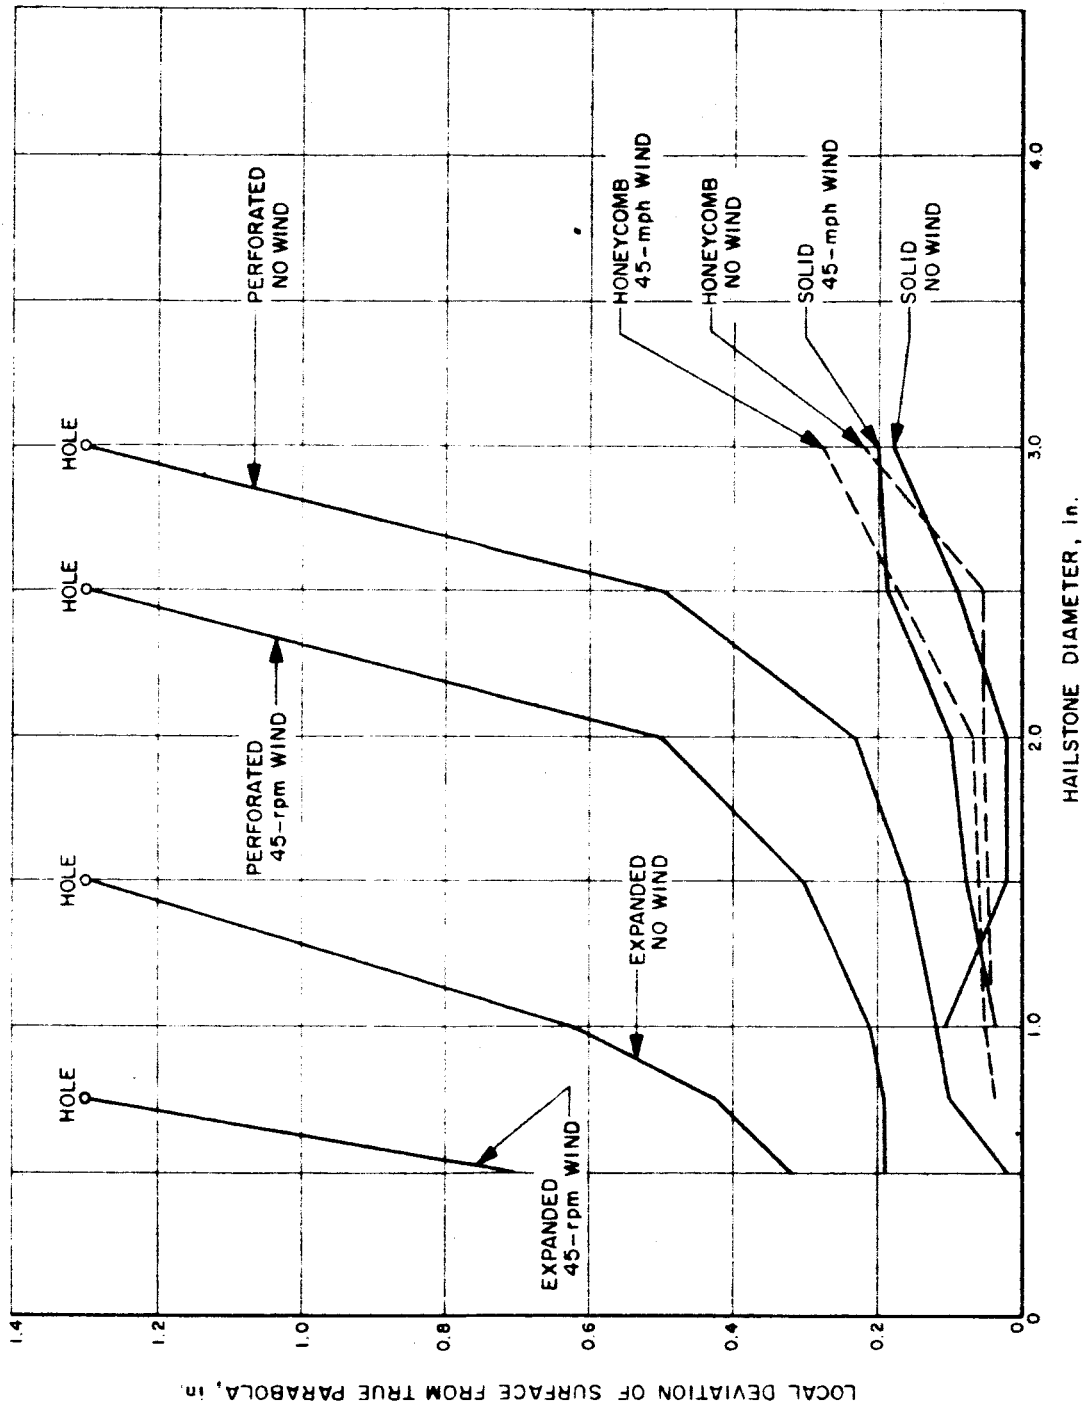
Fig. 10. Multiple impacts

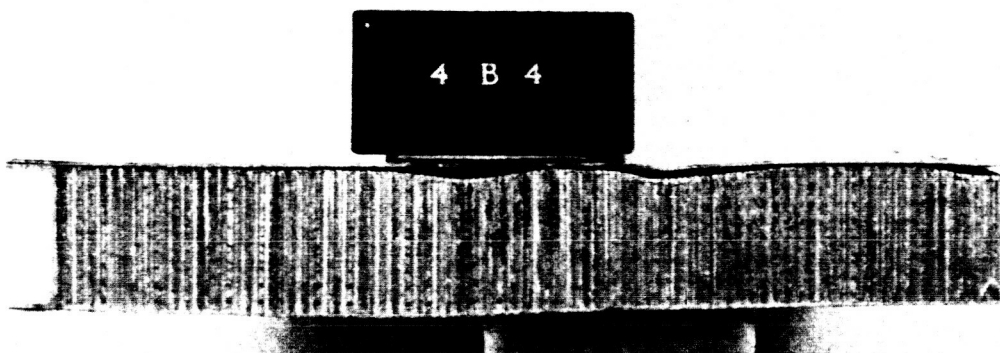
The "honeycomb" panel curve is deceptive in that, on cutting open the panels, it was discovered that the actual dent (as indicated by the crushed core, Figs. 11, 12, and 13) was greater than indicated by the surface measurements.

Fig. 13. Sectional view 4B4 of aluminum-plate honeycomb-core panel after hailstone impacts

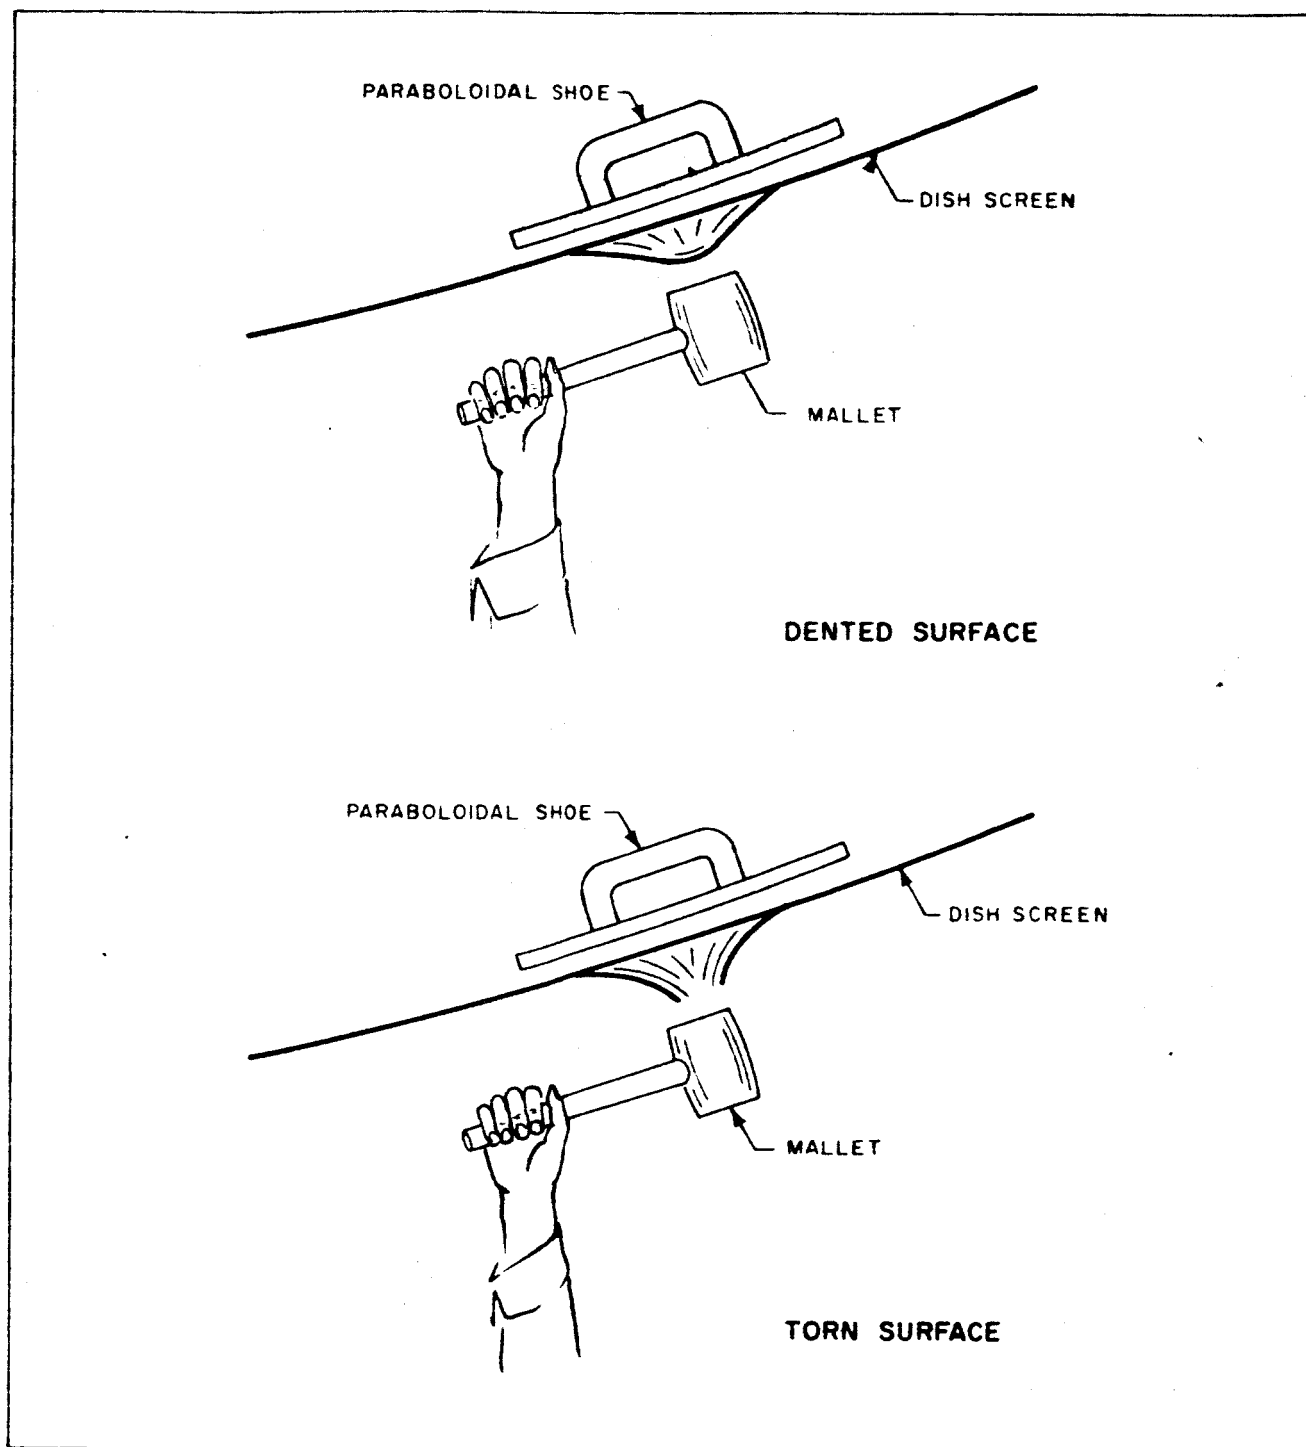
Fig. 14. Damaged panel surfaces being repaired with paraboloidal shoe and mallet

2. Paraboloidal shoes of aluminum and lead and wooden mallets should be provided for the African and Australian sites. Then, if hail damage occurs, the dish surface may be worked back into shape much the way automobile bodies are restored.
3. The items listed in Section IX E should be protected with shielding where possible. It appears that the shielding must be of 1/8-in. aluminum or heavier.
